Chrysler A-604 (41TE/AE) A-606 (42LE) Overdrive Clutch PowerPack®

ALTO PART #077757 & 077757A

INSTALLATION INSTRUCTIONS

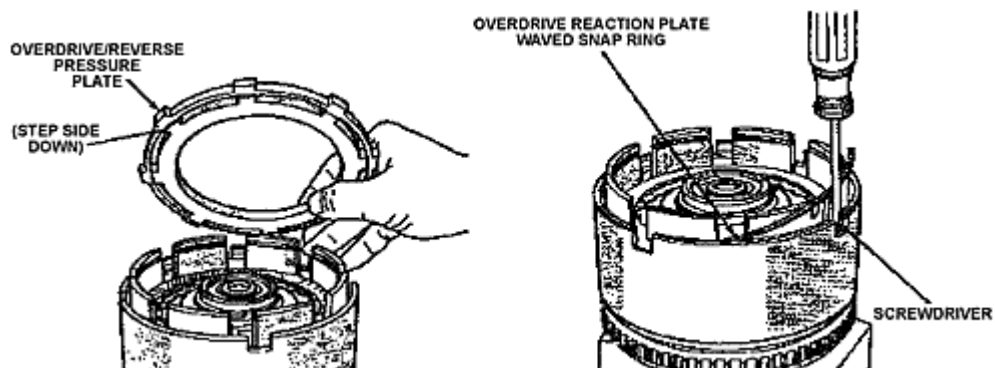
4. Install the clutch retainer housing waved snap ring (.61" thick) as illustrated in Fig. 1.
5. **Caution.** Install the OD/REV pressure plate with the "**THIS SIDE DOWN**" stamp as illustrated in Figure 2, against the top Overdrive friction plate.

2. Install the UD friction and steel plates, UD pressure plate and pressure plate snap ring.
3. **Please read carefully:** There are a total of five (5) friction plates in this kit. One of the friction plates is .085" thick. Install this .085" thick friction plate as the FIRST friction that rests against the top of the UD pressure plate then install the remaining steel and frictions plates in the usual manner.

6. Using the Chrysler #5059 tool or its equivalent to lightly press the OD/REV pressure plate down, install the OD/REV pressure plate snap ring. Ensure the snap ring is fully seated.

7. Check the Overdrive clutch pack clearance which should be .055" - .065". Completely install the Reverse clutch pack in the usual manner followed by the Reverse clutch pressure plate and top snap ring. Air check all three clutch packs to ensure that all the components are fully seated. As you apply air pressure to each individual clutch pack the remaining two clutch pack friction plates should have some clearance and spin freely. Now recheck the Overdrive clutch pack for .055" - .065" clearance. **Tech Note:** The factory specification for the Overdrive clutch pack clearance is .042" - .096". However, we have found through volunteer field test shops that if the clearance is below .048" with this kit installed, something in the input housing isn't assembled properly. Please be careful.
