AISIN WARNER / BORG WARNER

AW TF60-SN (09G) K-2 Sleeve 2003-On

Repair Kit for Rear Cover Sleeve

ALTO PART # 129355A

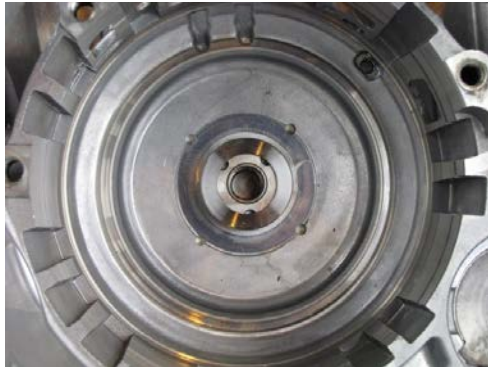
(1) The TF-60SN K2 clutch sealing ring sleeve can rotate and cause clutch failure

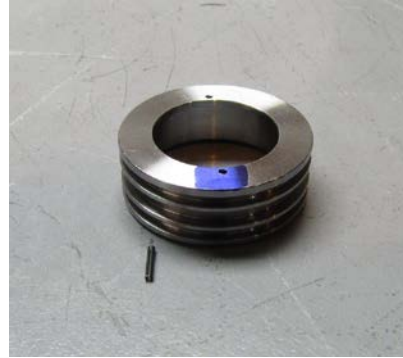
(2) Alto replacement sleeve to fix the case 129355A contains sleeve and locking roll pin

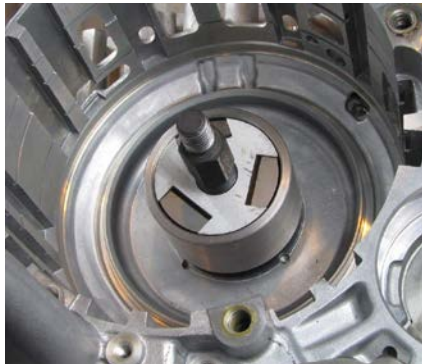
(3) Remove the sleeve from the case with the appropriate puller, you can heat the sleeve before removing

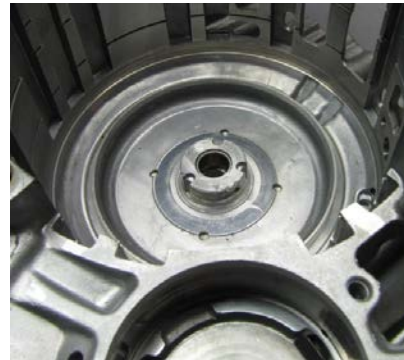
(4) Now might be a good time to replace the bushing

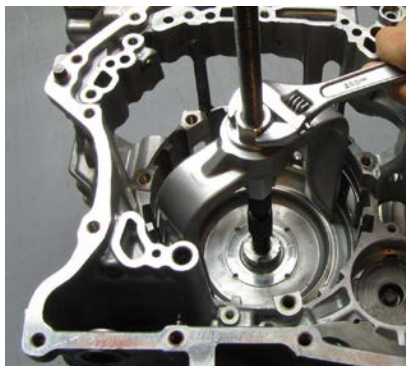
(5) Remove the bushing using a blind hole puller

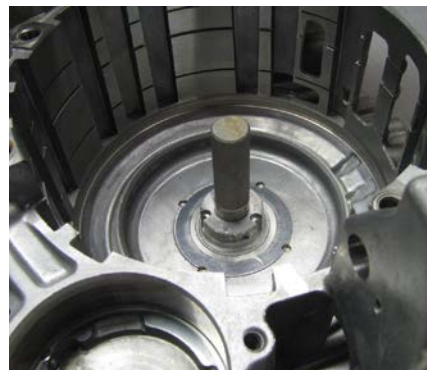
(6) Use bushing driver to properly install new bushing

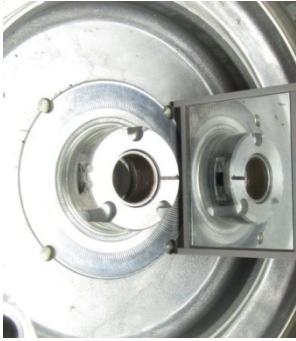
(7) **Alto 129355A Sleeve Installation**, Mark the case to insure proper alignment of oil circuit

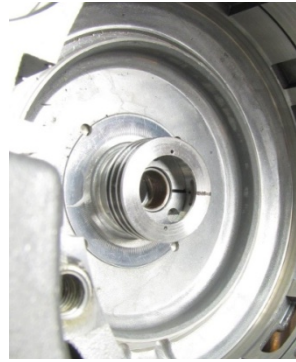
(8) The slot in the case feeds the sleeve case and sleeve slots must be aligned

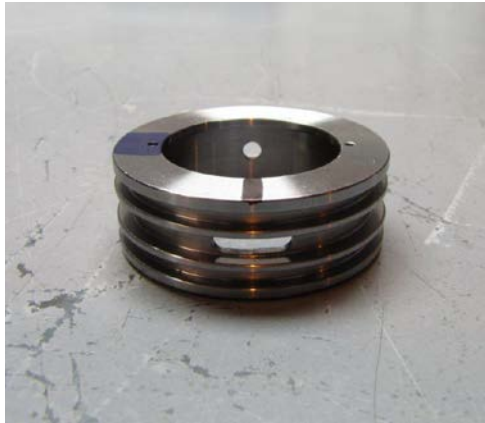
(9) Mark the sleeve above the slot If you are going to use any type of locking substance, apply it to the case

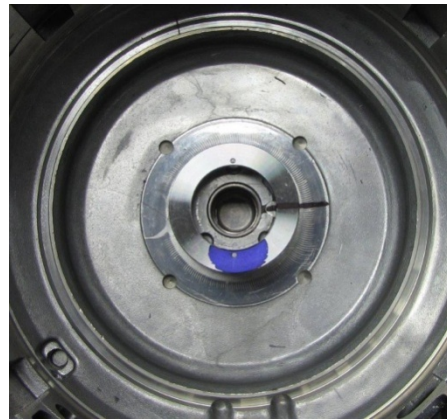
(10) Place the sleeve onto the case with marks aligned, and blue tinted hole at 6:00 o'clock

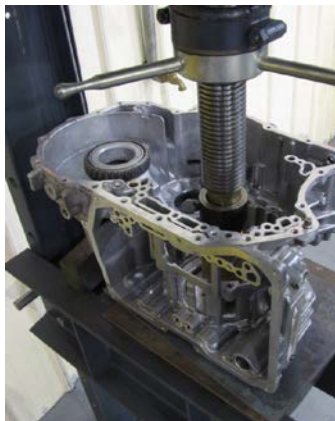
(11) Press the sleeve into place

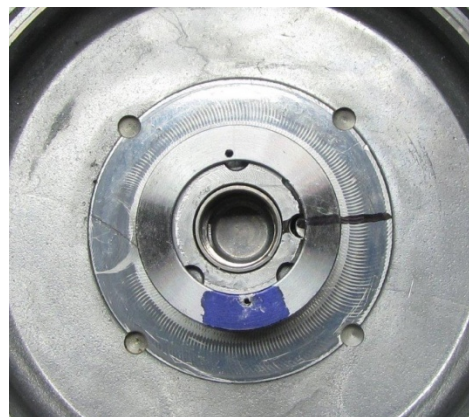
(12) Drill a .062" / 1.58mm hole .385" / 9.78mm deep, drive the roll pin in to prevent the sleeve from rotating, remove any burrs
