AltoUpdate...

MAKE	TRANSMISSION	APPLICATION	YEAR
GM	TH700-R4	SERVO PIN (MODIFIED)	82-On
DESCRIPTION & NOTES...

New! Original Equipment Improvement® Servo Pin (Modified) Alto #057301...

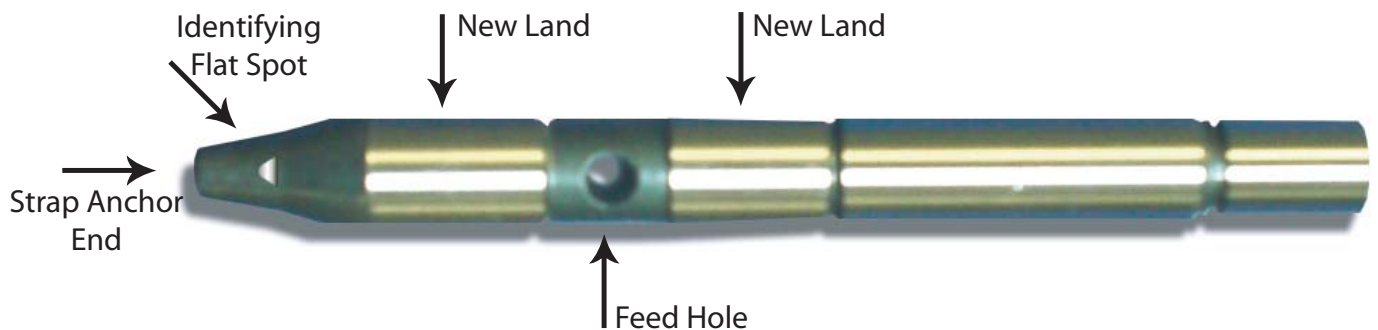
When rebuilding the 4L60 / 4L60E / 4L65E / 4L70E you may encounter clearance problems with the 2-4 band. Due to drum changes, band changes and case changes there may be too much or too little clearance. GM has three size pins, but the longest may not be long enough.

Alto now offers an OEI® Servo Pin (Modified) #057301 that is extra long and hardened. This pin can be ground to length to meet the specification. The new pin also offers new lands to make a better seal between the case and pin. The Alto pin is identified by a small flat spot ground into the strap anchor end.
