**Mitsubishi/Hyundai/Chrysler KM Series
Overdrive PowerPack® #059757 or
Overdrive PowerPack® w/Seal Kit #059935PWR**

INSTALLATION INSTRUCTIONS

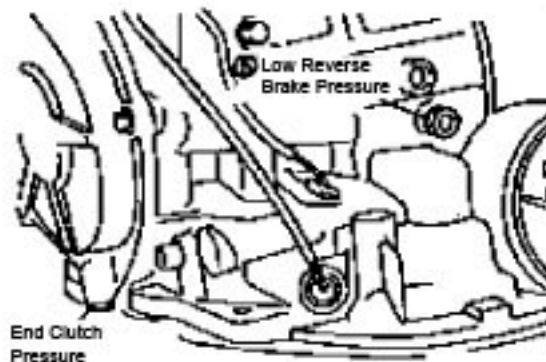
Figure 3

These transmissions experience many leaks in the end clutch apply circuits. It is always a good practice to check end clutch pressures after rebuild. For location of pressure tap, see Fig 3.
