New Product Release

E4OD – 4R100 / Overdrive Return Spring Snap Ring
Alto Part # 026269HD

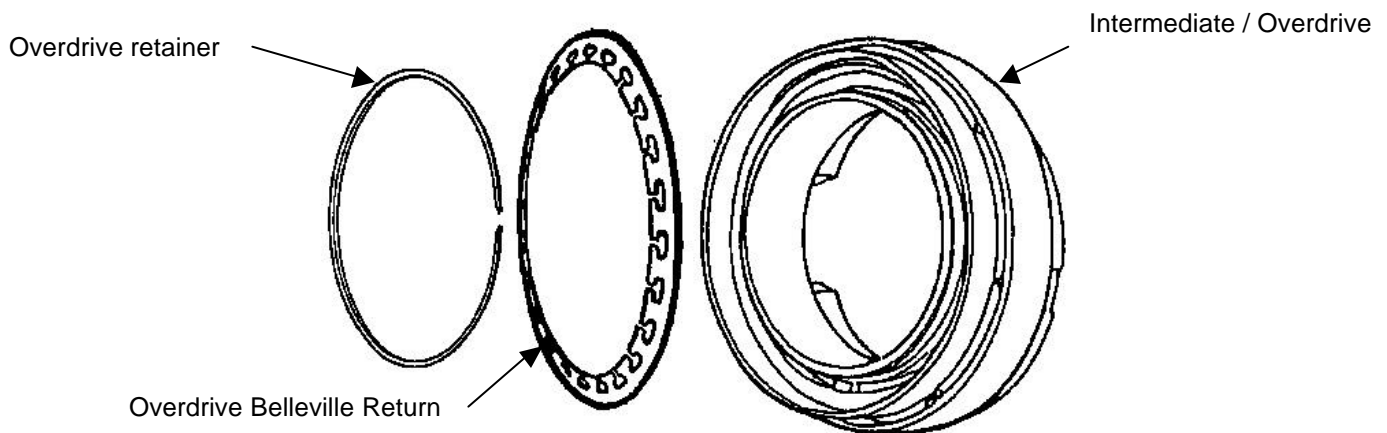
Problem: Harsh 3 – 4 shift, damage to overdrive clutch pack. The snap ring that retains the Belleville return spring in the overdrive clutch will fold or roll out of the snap ring groove. This will give you a harsh 3 – 4 shift. The contributing factor for this failure is the width of the snap ring land. It is too wide, and this allows the snap ring to tip up in the land and eventually roll out of the snap ring groove.

Alto Products Corp. snap ring part number 026269HD is thicker than the improved OE snap ring. This added thickness does not allow the snap ring to tip or roll out of the snap ring land / groove. Be sure to include this valuable updated snap ring in every E4OD / 4R100 rebuild.
