AltoUpdate...

Premature Clutch Failure in the Mercedes 722.6 Resolved with Alto Torque Converter Clutch Plates...

Year/Model: C&E Class '97-On, S&SL Class '96-On, SLK230 '98-On, ML '99-On

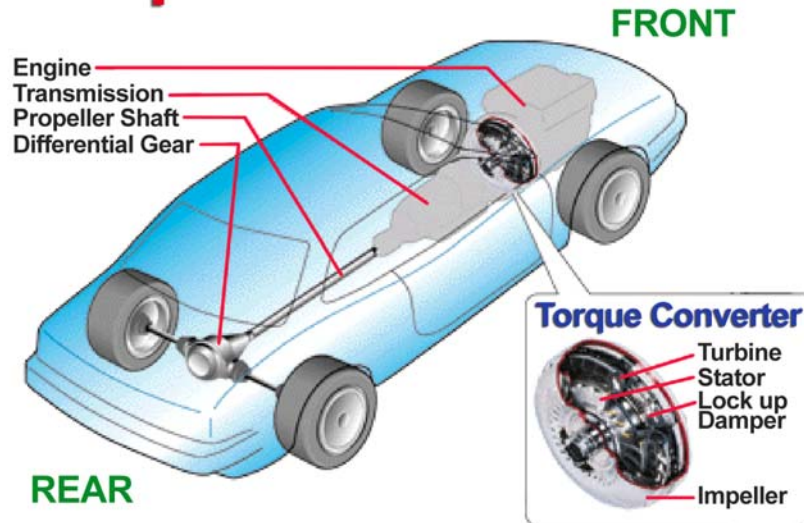
Torque Converter

Problem: Many reports of premature clutch failure in the torque converter of the Mercedes 722.6.

MERCEDES 722.6 CONVERTER STACK-UP

Alto#	Qty	Description	Specs.
141714	2	Red Eagle Frictions	.107"/2.72 mm
141715-177	2	Steel Plates	.069"/1.77 mm
141715-390	1	Steel Plate	.155"/3.9 mm

Solution: Alto #s 141714 friction plate, 141715-177 and 141715-390 steel plates make up the lock-up device in the 722.6 torque converter. Alto has produced these high wear, high torque friction plates in Red Eagle® friction lining.
