AltoUpdate...

MAKE	TRANSMISSION	APPLICATION	YEAR
Allison	540 Series	3rd Clutch CaseSaver™	'70-On
DESCRIPTION & NOTES...

New Allison 540 Series CaseSaver™ Alto #055758...

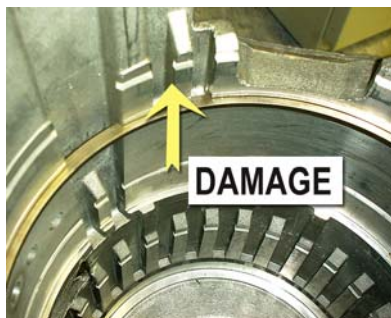
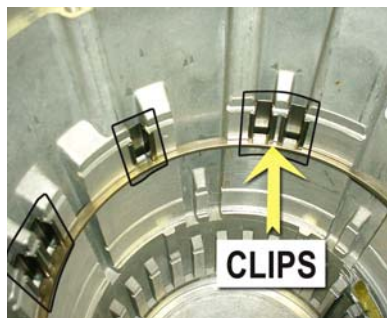
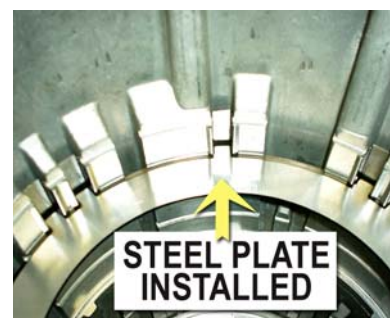
Alto Kit #055758

Allison transmissions have encountered a problem with the 3rd clutch steel plates "knocking" into the case lugs. This introduces large quantities of aluminum into the hydraulic system and can also cause delayed engagement.

Alto Products Corp. is the only aftermarket manufacturer to offer a CaseSaver™ kit for this problem. The spring steel clips fit into the damaged case, providing a smooth hard surface for the special modified steel plate to fit. The teeth of the friction clutch have also been hardened to help prevent wear. By using this Alto CaseSaver™ kit, you can reduce your costs by salvaging a previously worn and/or unusable case.

ALTO #	QTY	DESCRIPTION
055300	9	3rd Range Case Saver Clips
055704B250	3	3rd Range Hardened Spline Friction Plates
055705A255	3	3rd Range Modified Steel Plates

The stack-up of the transmission clutch pack is the same method as OE. Prep the case by removing any damaged area that will prevent installation of the CaseSaver clips. Install the 9 clips, proceed with normal installation of the steel and friction plates.
