## **Forward Drum Saver**

4EAT-F – Ford Escort, Mercury Tracer (baby ecat) F4A-EL – Kia Sephia, Mazda 323, MX3, Protégé

## **ALTO PART # 081755**

## **INSTALLATION INSTRUCTIONS**

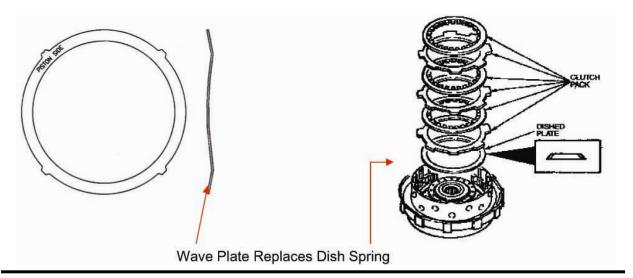
Check that the clutch clearance is .039" (1.0mm) to .047" (1.2mm) by inserting a feeler gauge between the snap ring and the top pressure plate. The feeler gauge should be inserted directly over the raised peak of the Alto Wave Cushion Plate. This will be the tightest clearance area.

Install the piston, followed by the Alto Wave Cushion Spring with the marking **Piston Side** down against the piston. Install a steel plate then a friction plate, repeating this until all steels and frictions have been used. Install the top pressure plate **This Side Up** and snap ring. Air check the drum setup several times to seat all the components.
